## IMPROVING A VIBRATORY FEEDER'S AMPLITUDE (Model 5 Base Unit)

IE03.01

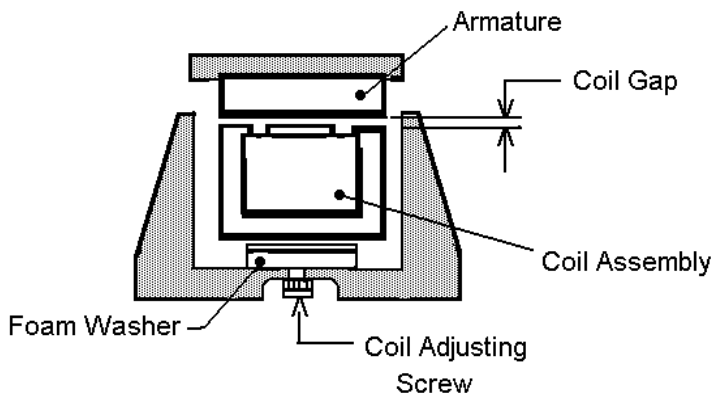
MODEL 5 BASE UNIT

If the vibratory feeder appears not to move the parts at a high enough rate, it is possible that a small coil adjustment is required. One of the reasons this adjustment may be required is a difference between the line voltage at the manufacturing plant and the line voltage at the customer's facility. Another reason could be damage to the vibratory feeder (or at least a change in the mechanical settings) caused by the unit being dropped (generally in shipping).

Refer to the drawing below and follow this simple *coil adjustment* procedure:

- Locate the COIL ADJUSTING SCREW.
- Turn the controller ON and make sure power is applied to the vibratory feeder's coil.
- Set the controller dial to the full-clockwise position (maximum output).

- Insert a  $\frac{5}{16}$  inch allen wrench into the COIL ADJUSTING SCREW and turn it in a counter-clockwise direction until the COIL ASSEMBLY comes in contact with the ARMATURE pole piece under the top casting. A coil-to-armature hammering sound will be heard.

- Note the position of the allen wrench handle relative to the base casting. Slowly turn the COIL ADJUSTING SCREW in a clockwise direction. The feeder's amplitude will begin to increase. If you turn too far the feeder's amplitude will then decrease. Stop and note the angular position of the allen wrench handle. A comparison with the starting position will give you a feel for the range of adjustment. Turn the wrench counter-clockwise to regain the highest amplitude setting.
